Extrication Challenges Of Advanced Steel in Vehicles – Part 1

- SUBJECT:** Advanced Steel
- TOPIC:** Extrication Challenges of Advanced Steel in Vehicles, Part 1
- OBJECTIVE:** Review the cutting capabilities of vehicle rescue tools including hand tools, electric cutters, air-powered cutters and hydraulic rescue system cutting tools.
- TASK:** Given the information contained in Part 1 of this series, the rescuers will be able to assess the capabilities of the cutting tools carried by their department for vehicle rescue work that involves vehicles built with reinforced A-pillars, B-pillars and roof rail structures.

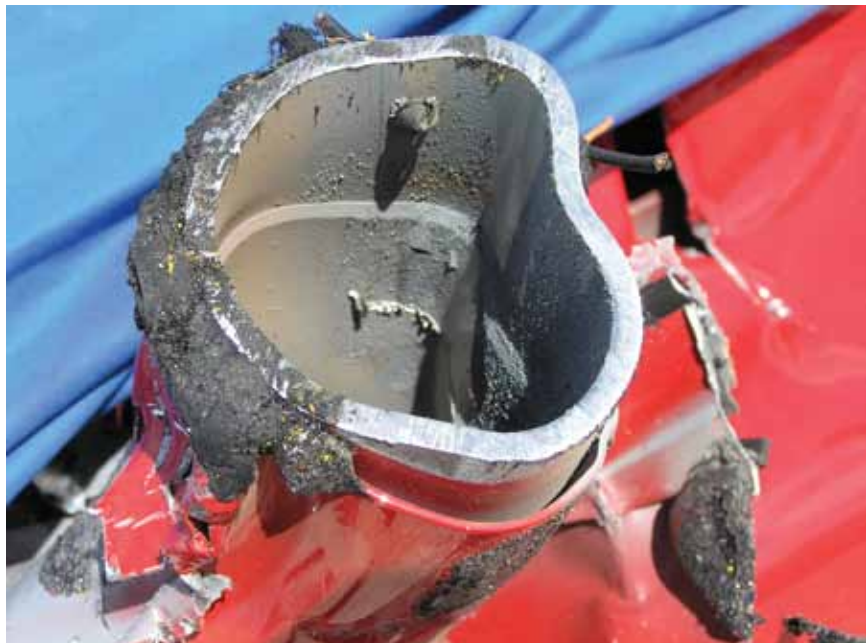
This image shows a cross section of the A-pillar of a Volvo C-70 automobile. The pillar metal is just shy of being quarter-inch-thick steel. Up until now, the typical automobile A-pillar that we encounter is approximately only one-16th-inch-thick steel.

In this first installment of our five-part series, we focus on the "more steel" approach to vehicle crashworthiness. Two good examples of the "more steel" solution can be found inside Volvo and Subaru vehicles. Volvo's C-70 auto for example, has A- and B-pillars constructed with nearly 1/4-inch-thick walls of steel. With a typical vehicle using merely 1/16-inch-thick layers of steel to create a roof pillar, the Volvo vehicle will challenge rescuers working to cut the roof off, open up a crushed sidewall, or move the dash and firewall. This author's experience accomplishing extrication tasks on these Volvo vehicles confirms that the thicker steel approach to crashworthiness makes for one tough vehicle to tear apart.

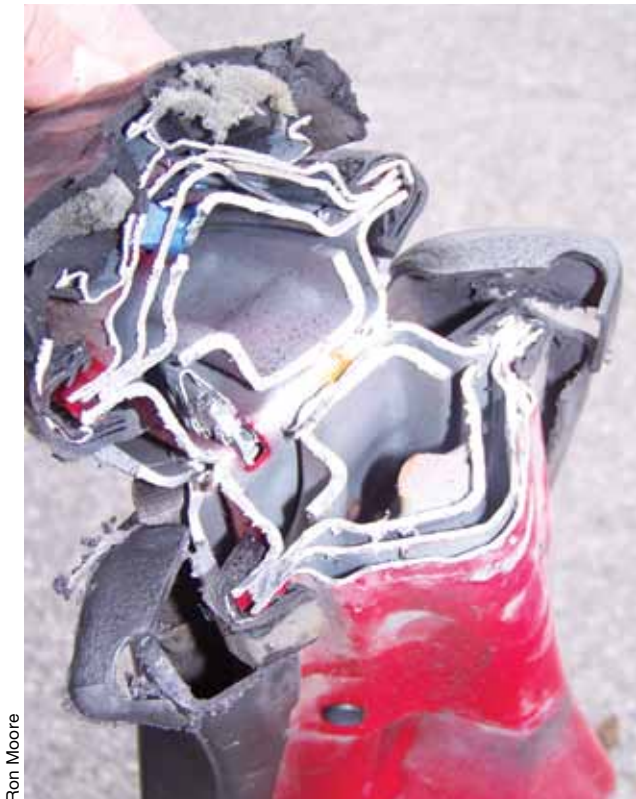
This B-pillar from a Subaru Impreza vehicle has been sliced open to expose the inner layers of steel and the steel rebar welded inside. A power cutter would have to cut through at least six layers of steel plus the solid rebar if it were to be successful.

ers of sheetmetal, but may encounter one or even two steel rebar rods welded inside the hollow of the pillar.

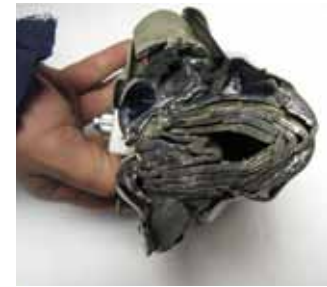
The 2008 Camry B-pillar crushed under the power of the hydraulic rescue cutters being used by the Rockville, MD, volunteer firefighters but did not cut through. Depending upon where you count, the cutters stalled out while trying to sever eight or as many as 14 layers of steel in the pillar. Later, a rotary saw with an abrasive blade cut the pillar.
